### Pre-Action Pipe Samples after 7 years in 99% Nitrogen

The following photographs are of 1" schd. 40 black steel pipe that was removed from a pre-action sprinkler system on 6/12/2013 after 7 years of operation at a pressure of 40 psig of 99% nitrogen supplied and maintained by a Holtec Nitrogen Generator.

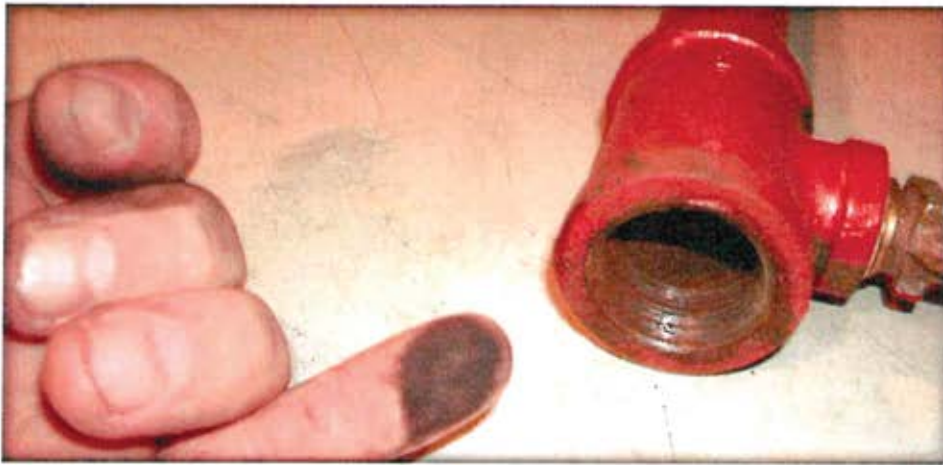
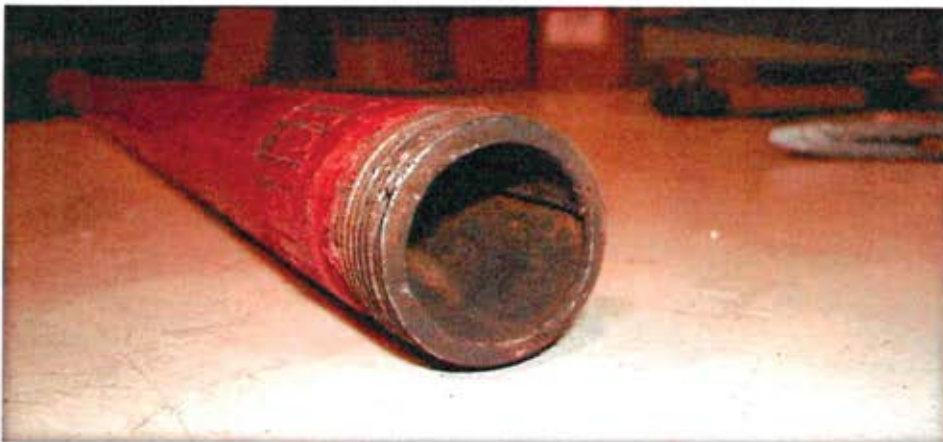
Other than a thin dusting of black magnetite ( $\text{Fe}_3\text{O}_4$ ), the pipe is not corroded and free of internal debris.
